SITE NUMBER: CW-L3-02
LOCAL NAME: Unnamed LB #2
WRIA:

NORTH COAST OFF CHANNEL SITE INVENTORY DATA

NORTH COAST OFF CHANNEL SURVEY
SUBSEQUENT SITE EVALUATION FORM

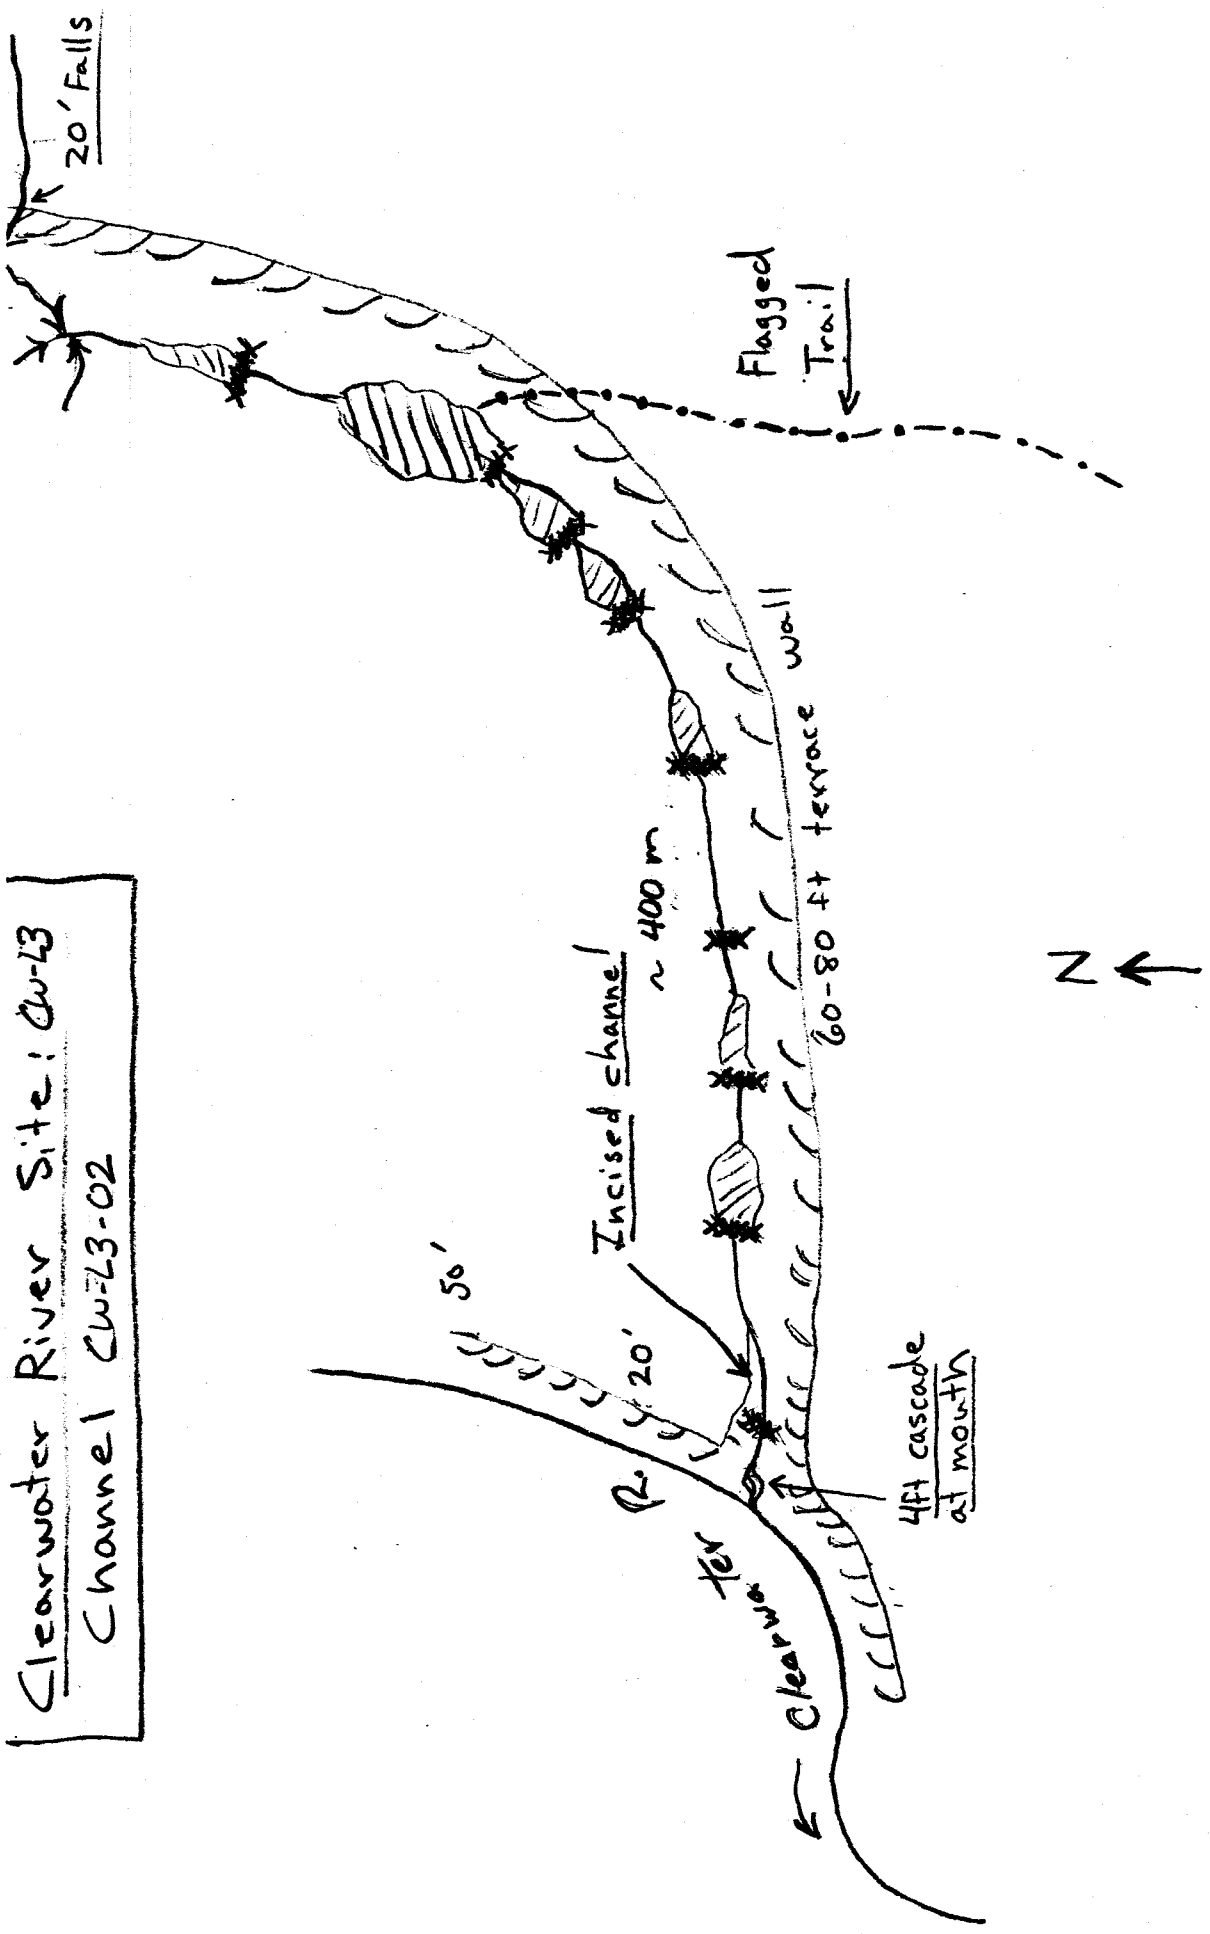
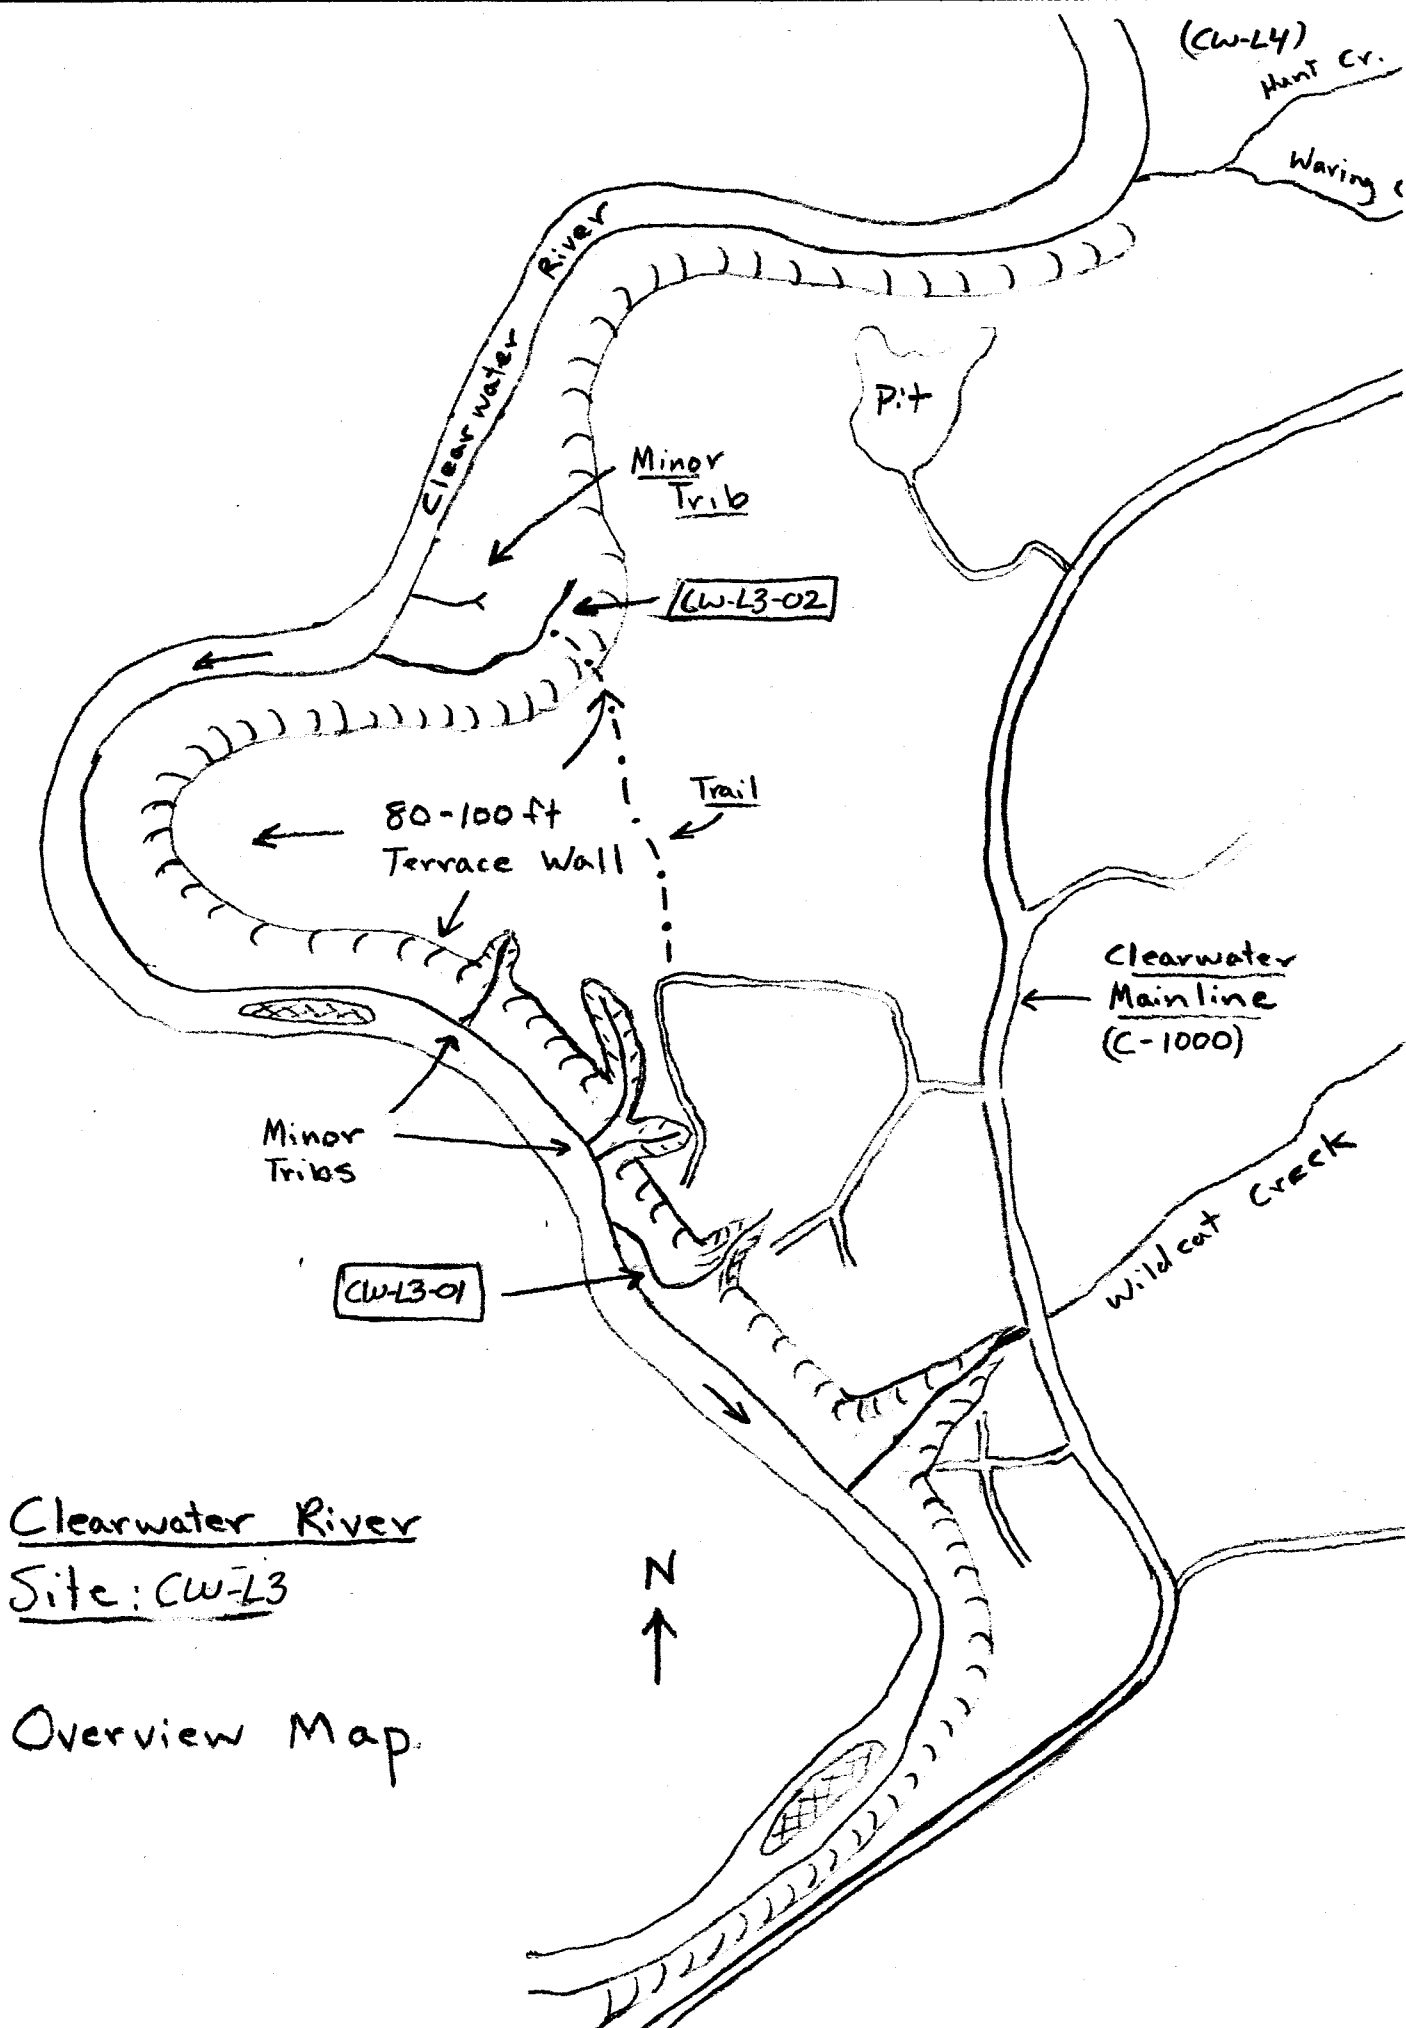
Clearwater River Site: Qw-23
Channel Cw-23-02

Sites were electroshocked in the middle to upper reaches of this channel (see map). Results are listed below:

Area (Sec.)	Effort	Results
1.) Two small beaver ponds just downstream from the foot of the trail.	147	No fish were caught.
2.) The 3rd pond downstream from the foot of the trail.	76	Caught 3 coho and rolled 2 other salmonids
